NASA TECHNICAL NOTE

NASA TN D-5207

INVESTIGATION OF SA-501 S-IVB AUXILIARY PROPULSION SYSTEM FLIGHT ANOMALIES

*George C. Marshall Space Flight Center
Marshall, Ala.*

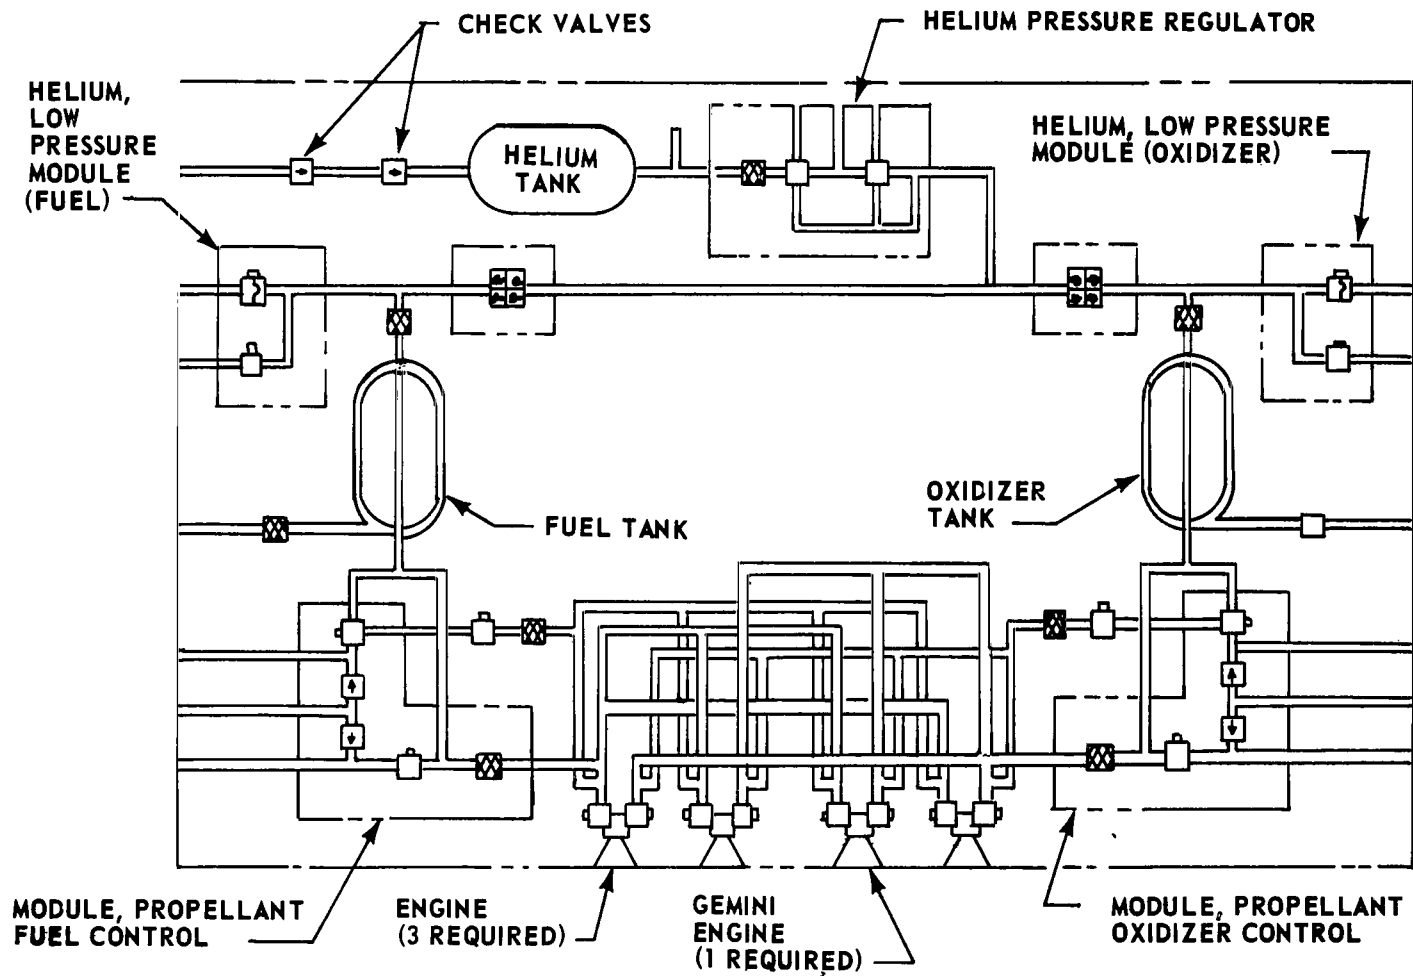
FIGURE 1. SATURN V/S-IVB APS SCHEMATIC

Examining the system (Fig. 1), it is noted that only propellant feed lines, a filter, propellant valves, and engine injector constitute the flow path from the tank outlet to the engine combustion chamber. The line size from the tank outlet to the filter entrance is 3/4 inches in diameter. Since this line feeds all engines, no flow restriction occurred in this section. The filtration levels for the filters are 10 microns nominal and 25 microns absolute. Theoretically, the maximum size particle that could pass through the filter would be 9.84×10^{-4} inches in diameter. The length of such a particle is indeterminate. The clogging of the filter by particulate contamination must also be ruled out since the flow for all four engines in each module passes through the filter, and effects of clogging would be seen on all engines alike. The size of the primary propellant feed line from the filter to the engines is 3/8 inches in diameter. The arrangement is such that the propellant flows through the filter into a cavity at the filter base in the propellant control module where it is fed from two manifolds to the engines. Thus, if flow was restricted in the propellant control module cavity, it would be seen by all engines but if it was restricted in the manifolds feeding engines 1 and 3, then engines 2 and 4 would be unaffected or vice versa. Stated simply, the problem occurred downstream of the propellant control module, either in the manifolds feeding the engines, or in the engines themselves.

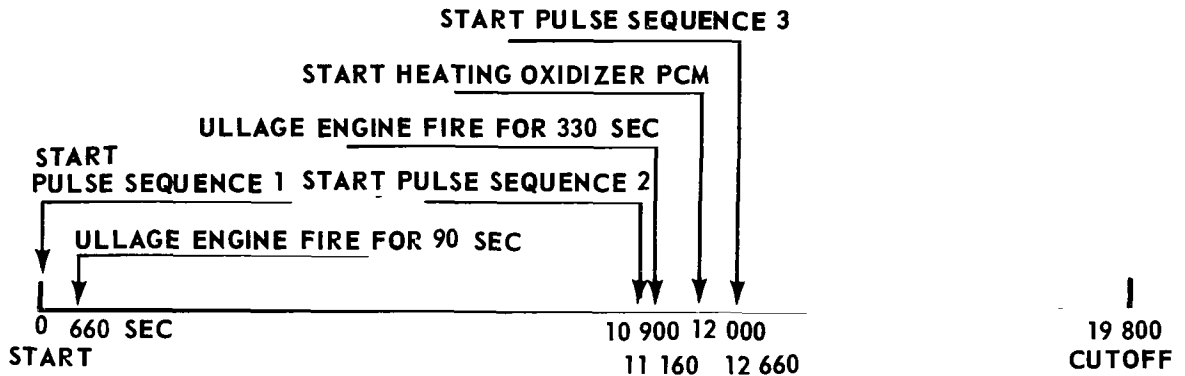
FIGURE 9. SEQUENCE OF EVENTS TIME LINE FOR SIMULATED "501" DUTY CYCLE

The simulated "501" APS duty cycle, as shown in Table 1, consisted of 529 pulses on engine 1, 1088 pulses on engine 2, 529 pulses on engine 3, and two steady state burns totaling 420 seconds on engine 4. Each attitude control engine pulse was 65 milliseconds in duration. Before beginning the pre-programmed firing cycle, 3-second firings were conducted on each engine to establish the steady state Pc operating level. Similar firings were conducted following the duty cycle. To provide the thermal simulation, the oxidizer control module, consisting of the fill valve, recirculation valve, filter, and supply manifold, was heated beginning at 12 000-seconds into the duty cycle using a 2.5 ampere infrared lamp. A photograph showing the heating apparatus and the area heated is shown in Figure 8. The significant events for the 19 800-second duration duty cycle are depicted in a time line shown in Figure 9.

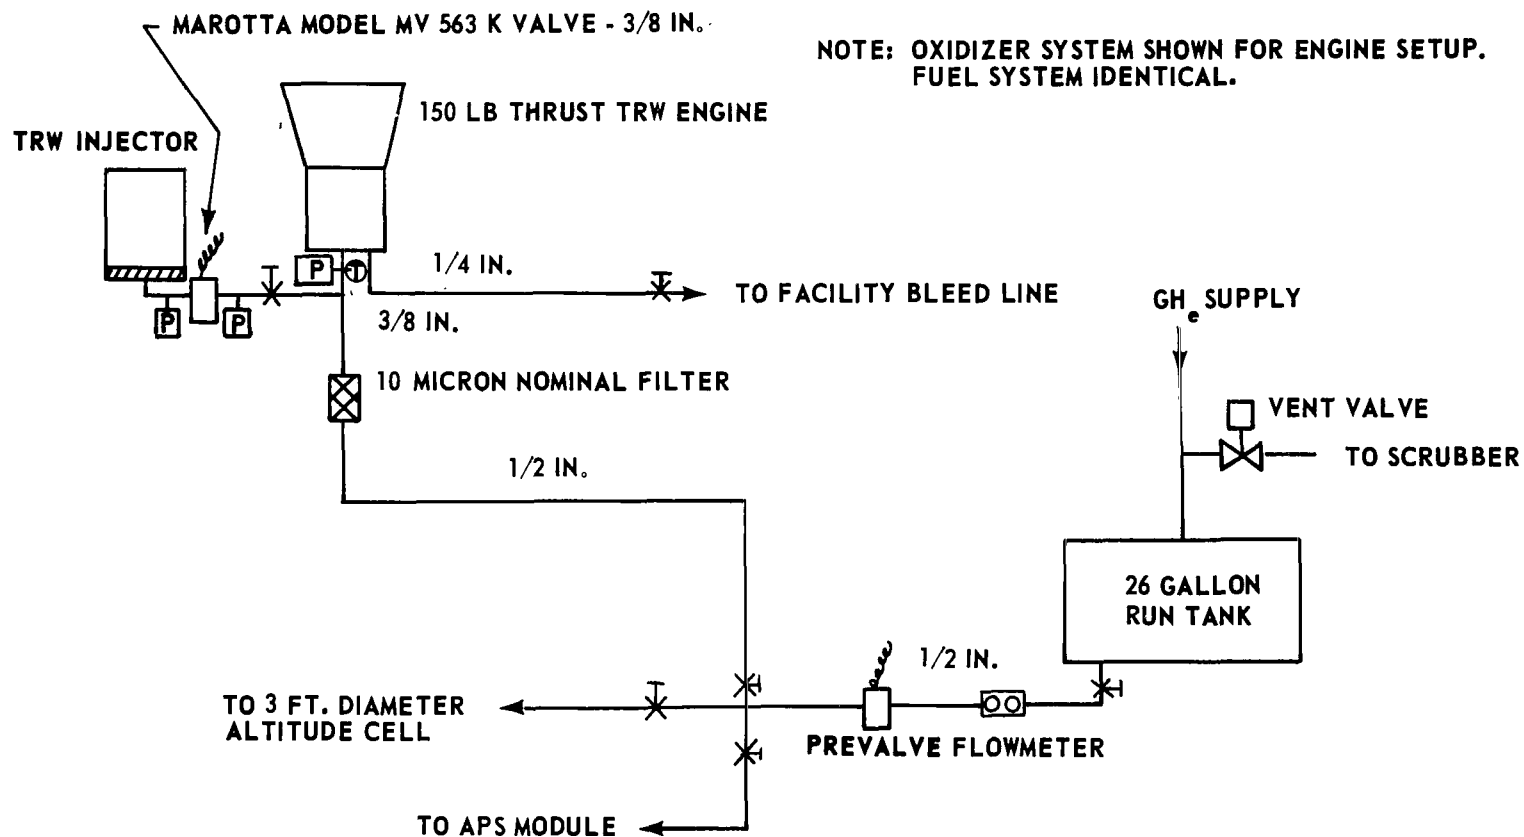
FIGURE 13. FACILITY SCHEMATIC FOR TRW ENGINE "SEA LEVEL" TESTS
AND INJECTOR FLOW TESTS

Two TRW engines were hot fired in a series of 16 tests at ambient pressure conditions. The engines were mounted in a "sea level" stand with the tubing schematic as shown in Figure 13. Propellants were maintained at the engine inlets under 20 psig blanket pressure during hold periods. The standard duty cycle for these tests consisted of three pulses: 250 milliseconds on — 500 milliseconds off, 65 milliseconds on — 500 milliseconds off, and 65 milliseconds on.

The initial engine tested (TRW SN 585) exhibited a P_c of 99 psia and O/F ratio of 1.630. After a 5-day hold period, the engine was tested again, using the identical inlet pressures as the first run. The P_c value was 70 psia with an O/F ratio of 1.003. The fuel flowrate remained nominal. Following the second test, the engine was disassembled and inspected by the Materials Division of P&VE Laboratory. Crystalline matter was noted at the entrance to the twelve 0.035-inch diameter oxidizer injector feed tubes. Although the tube area reduction caused by the material did not appear to be large, the effect of these particles on the tube surface roughness in the form of increased friction factor and reduced flow area was such that flow restriction could be experienced.

A series of tests was then begun on a second TRW engine (SN 526). An 11 percent reduction in P_c was noted during the initial 6-day period, and the P_c decreased to a low of 81 psia from the initial value of 99 psia (18 percent). Seven tests over a 21-day period were required to reach this level. As with the previous engine, the P_c decay was proportional to the decrease in oxidizer flow rate. In this case the O/F shift was from 1.631 to 1.300. Fuel flow rate remained constant. From the low of 81 psia the P_c began to increase again and stabilize at 94 psia after 4 tests in a 14 day period. A 10-second steady state run was then conducted and the P_c returned to the nominal value of 99 psia after 1.5 seconds burn time.

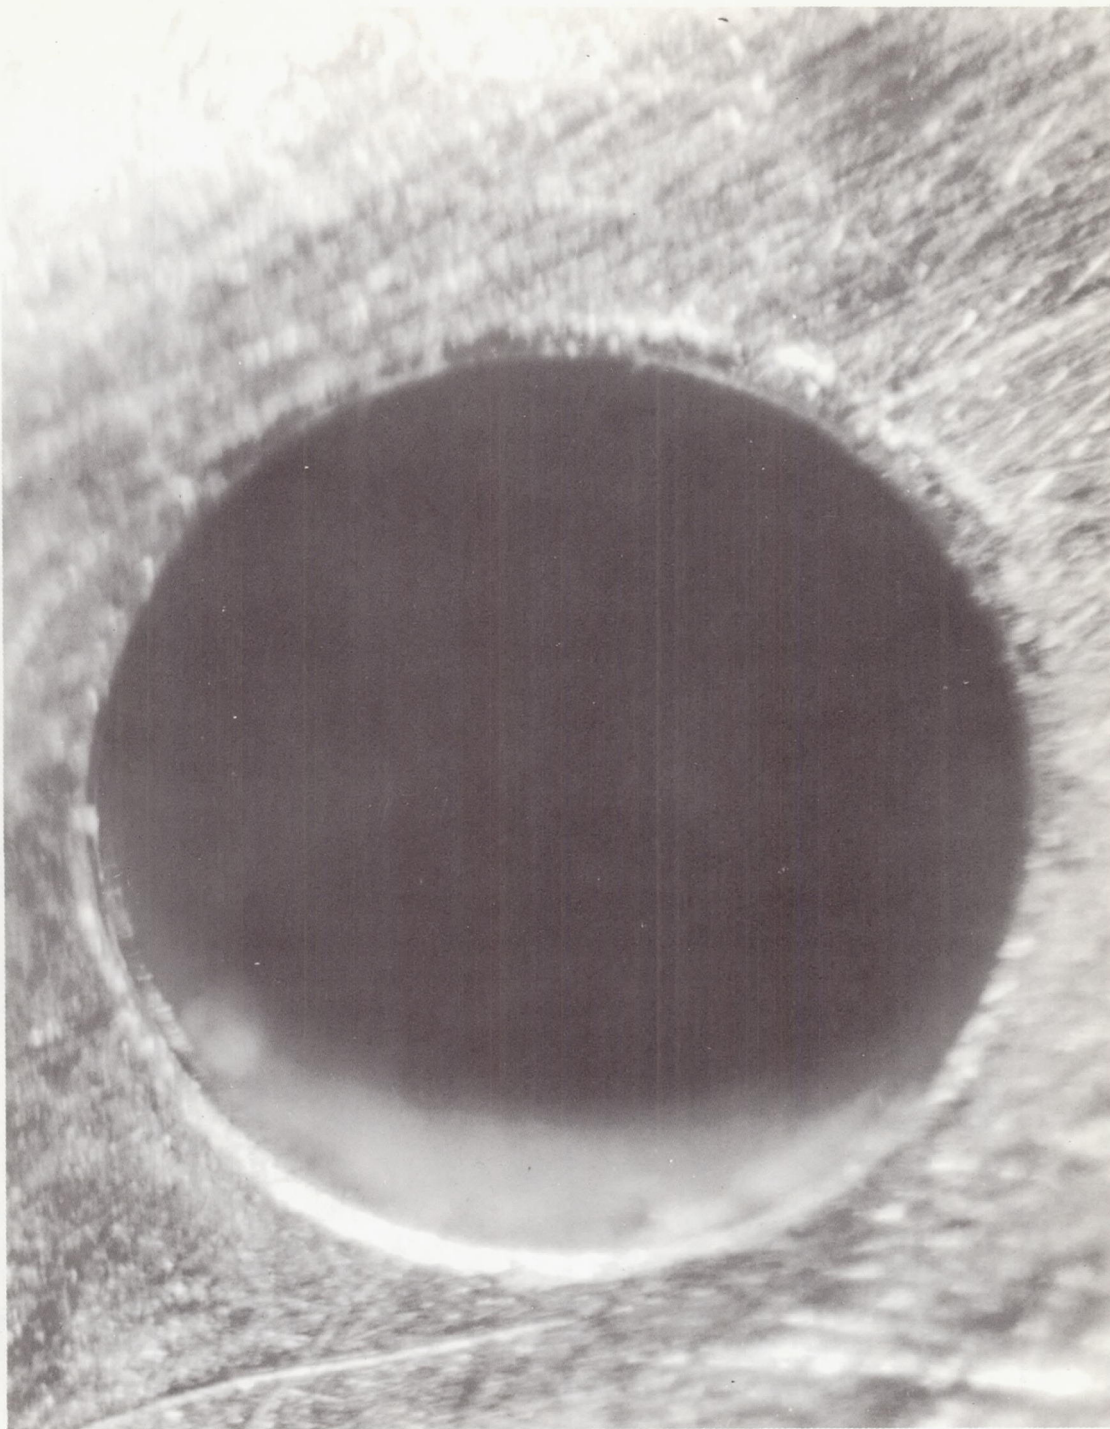
FIGURE 17. NORMAL INJECTOR OXIDIZER PASSAGE OUTLET

A 5-test series was conducted over a 16-day period on one injector (SN 106), and this injector was then removed from the stand and delivered to P&VE Laboratory for contaminant analysis. Microscopic examination revealed the presence of contamination at the entrance to the oxidizer tubes in the form of a greenish, jelly-like substance. Spectrographic analysis indicated a high percentage of nickel and lesser percentage of iron and chromium in the contamination. Although the injector was open to the atmosphere for a day or more during the laboratory examination, liquid was noted in the injector. The liquid was postulated to be nitric acid and litmus paper tests proved it to be acidic. Photographs were made and views of the contaminated portions of the injector are shown in Figures 14 to 17. Figure 14 shows the contamination in the oxidizer tubes entrance flange. Figure 15 shows the same view of a flange that had been cleaned. The other two photographs illustrate the difference in amount of corrosive attack on the front face of an injector at the outlet of the oxidizer tubes for two injectors, one which was used in this test (Fig. 16), and one used in early system tests (Fig. 17).
